**CIRCULAR LETTER
NUMBER 04-2007**

ROTAX
NEW AGE KARTING

NEW SUPPORT BRACKET 251720

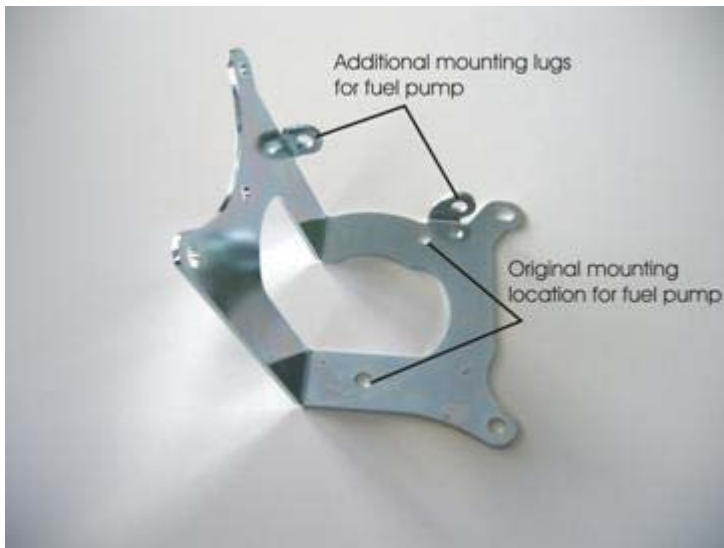
We would like to inform you about technical problem with new designed support bracket 251720.

The problem is that if the fuel pump is mounted on the additional mounting lugs (see picture above) on the side of the support bracket, that this could lead "due to vibration" to a crack of the support bracket in the area at the head of the first mounting lug.

Please inform your service centres and customers not to install the fuel pump on the side of the support bracket.

For the future the additional mounting lugs shall be removed from the support bracket and should be available in approximately 2 months.
